MultiCam™

Release Notes for MultiCam 6.9

November 19, 2013

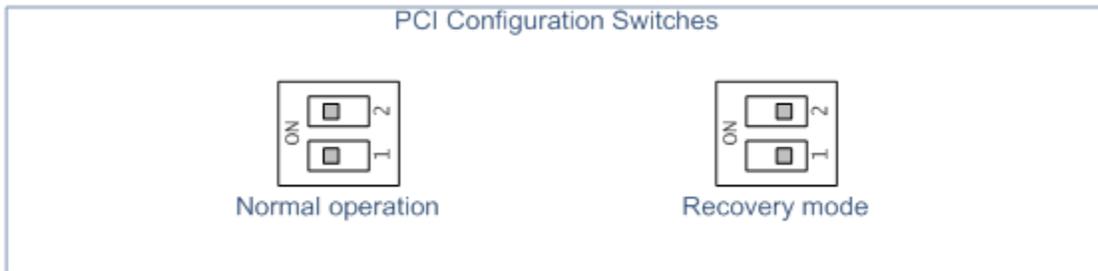
Grablink Base, DualBase, Full and Full XR feature a set of configuration switches. For normal operation of the board, both switches must be in the ON position.

Should recovery mode be enabled by error, the Grablink board appears as "GRABLINK Base/DualBase/Full/Full XR (Recovery)" in Windows Device Manager and is not functional. To restore normal operation, power off the PC, change the switches to normal position and then reboot.

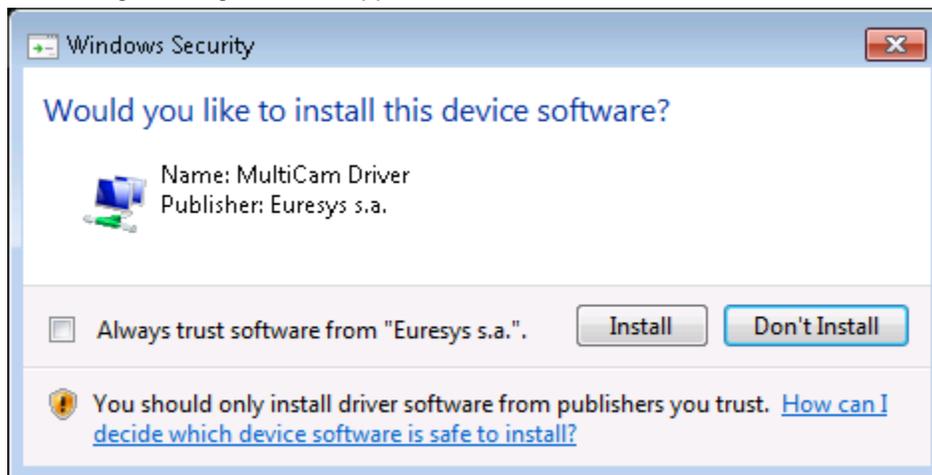
Since MultiCam 6.8.2.2066 our drivers have been signed with a new digital certificate. Consequently, in Windows Vista and later, the following message box will appear at driver installation:

All you have to do is to check the *Always trust software from "Euresys s.a."* option then click on the *Install* button. Once this has been done this message box will not appear again during subsequent installations. Note that the silent-mode installations will be blocked by this message until you perform this manipulation.
